# Water Conservation at Seneca Foods

Larry Lau

Chemical Engineering, University of Illinois Urbana-Champaign, Junior

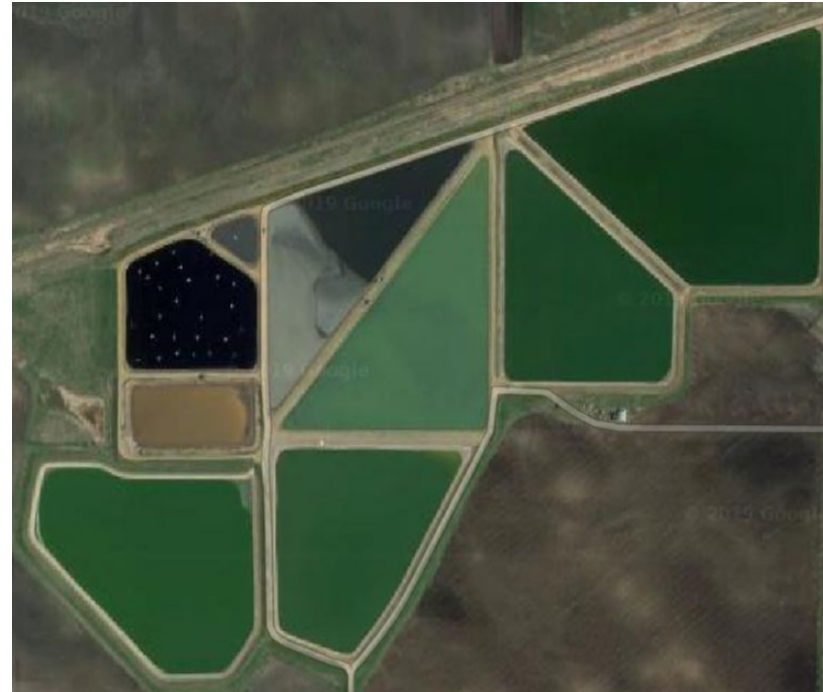
- Ponds are close to overflowing
  - Wastewater to ponds annually: 221,000,000 gallons
  - Maximum capacity of ponds: 292,000,000 gallons
- Water is not metered completely

Figure 2. Seneca Stabilization ponds

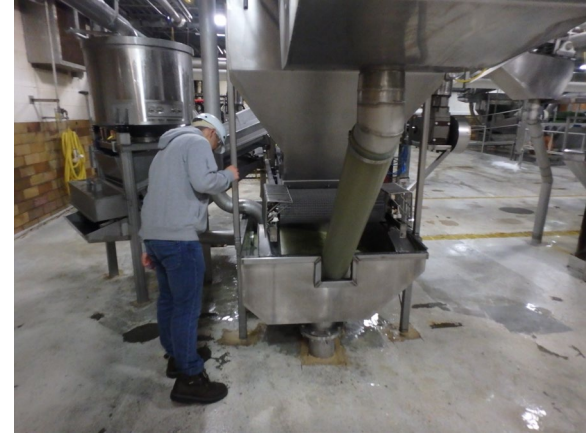
Figure 4. Dewatering belt

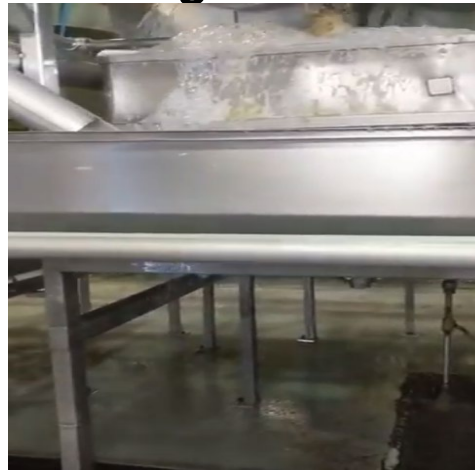
- 500,000 gallons of plantwater through system daily
- Overflow of around 50%
- Cannot be reused due to frothing solution
- Annual Cost of \$5400

Figure 5. Frothwashers

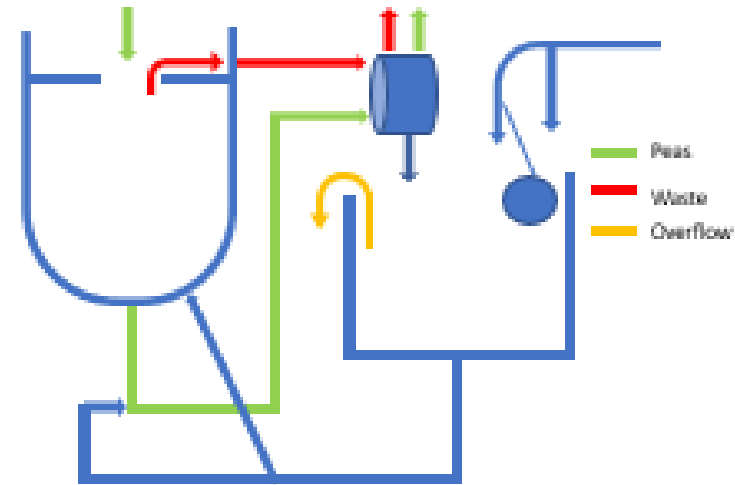
Figure 6. Frothwasher diagram

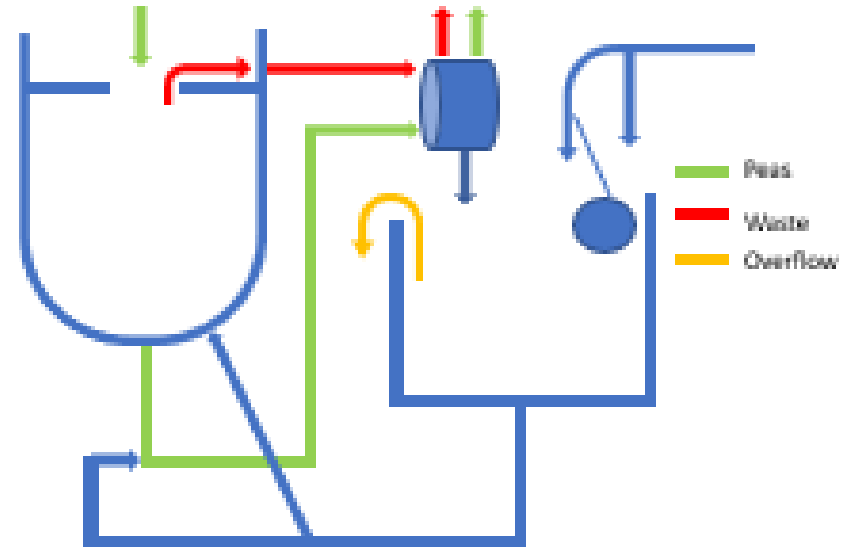
Figure 6. Frothwasher diagram

- Adjust/Add floats
- Replace broken valves
- Add signage for fill valves
- Increase splash guard height
