TCE Replacement Case Studies

Alicia McCarthy
Toxics Use Reduction Institute
University of Massachusetts Lowell

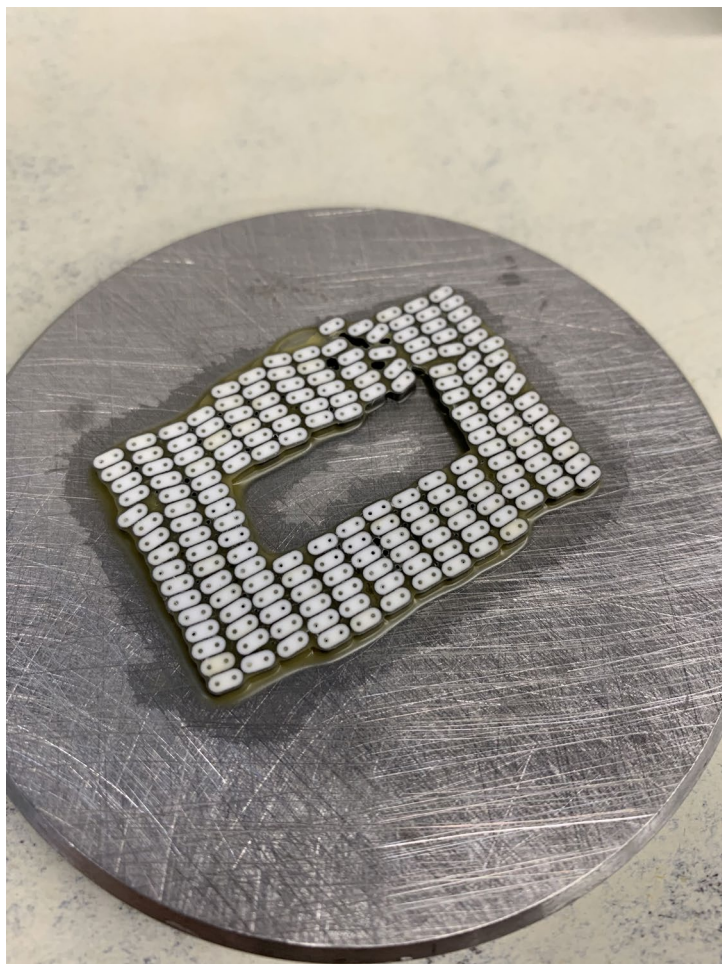
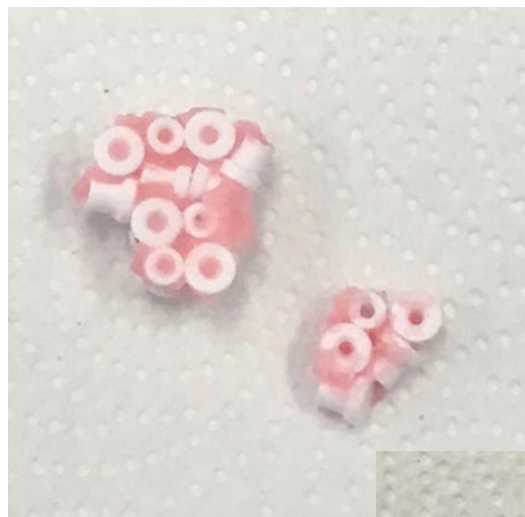
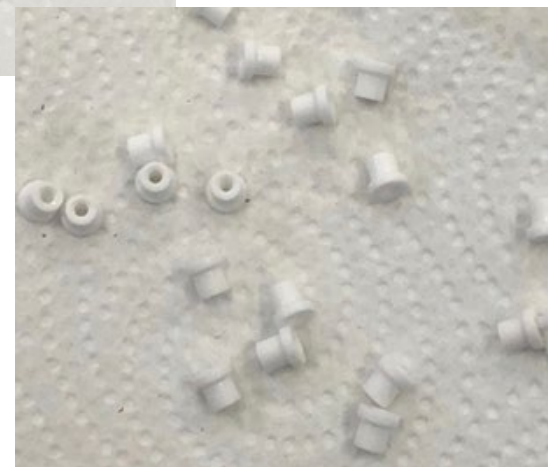
Case Study 1: Brown and Pink Wax

- Company working with ceramic, glass, and metal engineered parts
- Worked with TCE in a vapor degreaser to remove wax from parts
- Identified a mixture of Baking Soda and Borax in Water
 - Borax is an endocrine disruptor
- Worked with lab to identify alternative detergents

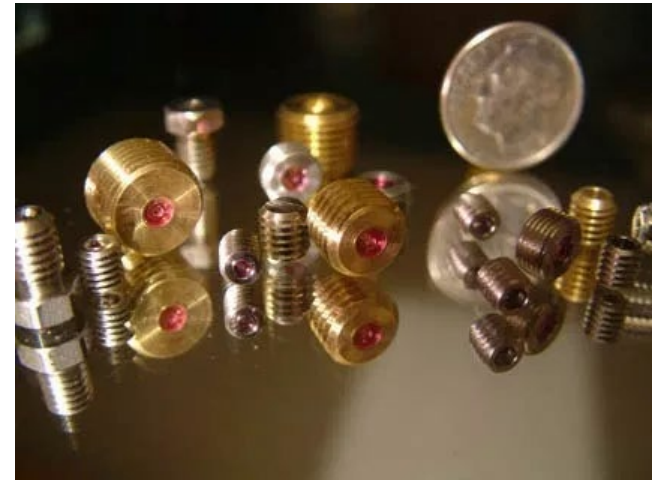
- Precision orifices
 - Pneumatic Fittings
 - Bicycle/ball pumps
 - Tire pressure gauges
 - Some nail guns
 - Hydraulic Nozzle and Restrictors
 - Fuel systems
 - Oil tools
 - Race cars
- What is being removed?
 - Lubricating/Lapping Oils; Dirt; Fibers; Fingerprints
 - Verification with microscope

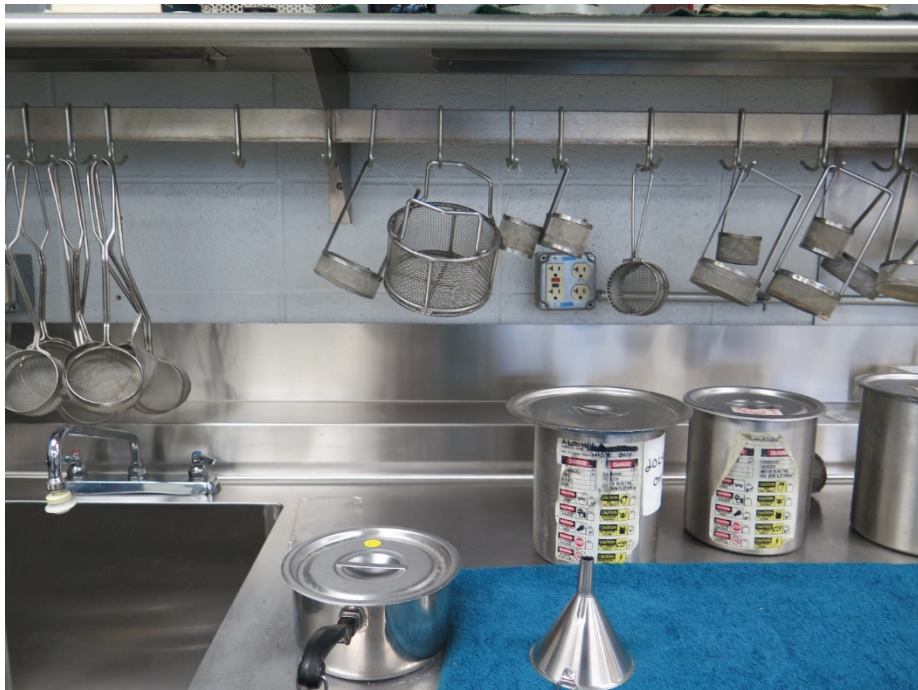
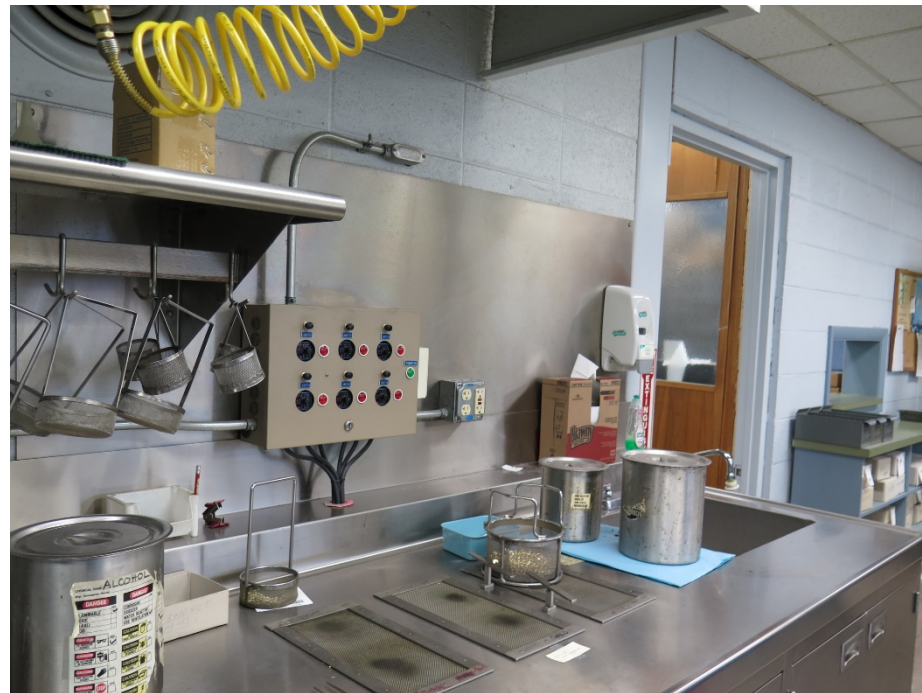
Case Study 2 – Cleaning Station/Dry Station

- Low flammability/ Non flammable
- Work quickly (1-5 minutes)
 - Current cleaning takes 5 seconds to swish and then heat dry
- No residue on or inside parts
- Reduced health hazards

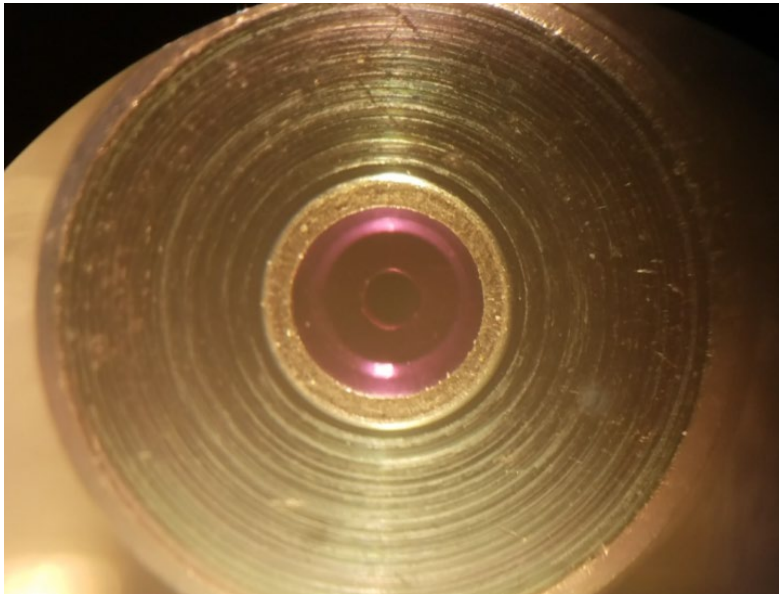
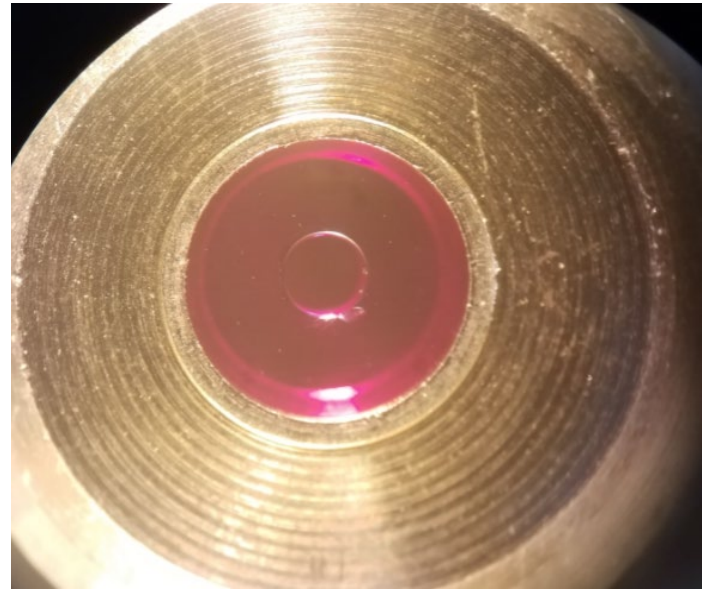
Case Study 2 – Clean vs Dirty Parts

Can you tell which one is clean and which one is dirty?

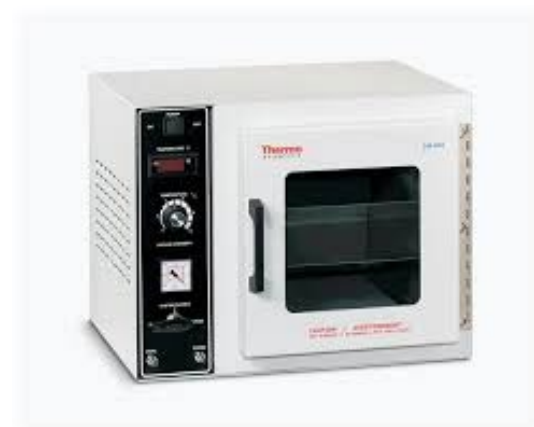
Case Study 2 – Cleaning Alternatives on Market

- Initial Review of Alternative Options
 - Aqueous Options
 - Left a residue even after rinse
 - Halogenated Options... So Nope.
 - Chlorinated Solvents
 - Hydrofluoroethers (HFEs)
 - Trans 1, 2 Dichloroethylene
- Hansen Solubility Parameters
 - Dimethyl glutarate
 - Great degreaser
 - Needed dry step – vacuum oven

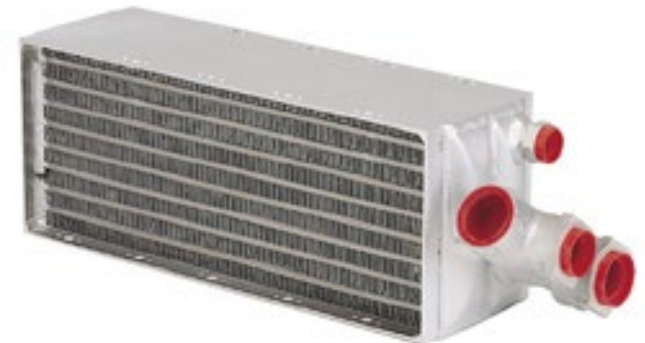
Case study 3 – Lytron

Phase I: Aluminum Fin and Flat Parts

- Could not use aqueous options due to substrate
 - Risk of corrosion
- Remove contaminants within 30 minutes
 - Blasocut Coolant
 - Oak Series Lubricant
- Verify cleanliness for customers
 - Contact angle
 - Gravimetric
 - Visual
- Interested in new equipment process
 - Vacuum Cycling Nucleation System (VCN)

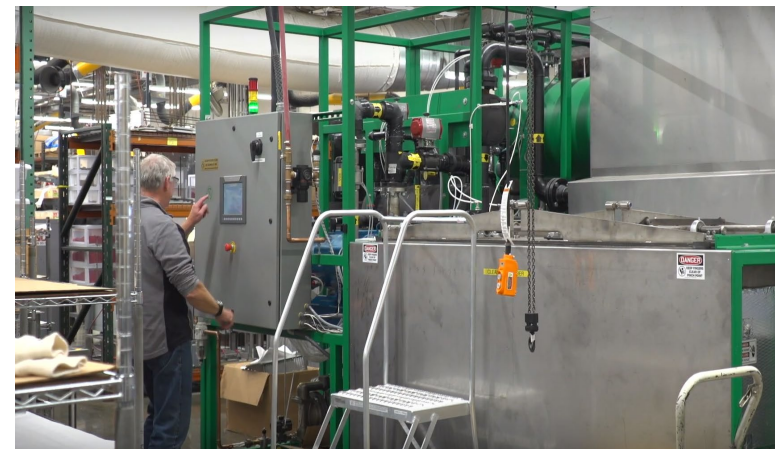
Case study 3 – Lytron Phase I Results

- Switched chemistry and added Vacuum Cycling Nucleation (VCN) equipment
 - Removed 6,000lbs of TCE
 - Recycle 98% of solvent
 - However, using DCE....
 - Not finished! HSPiP to identify alternatives

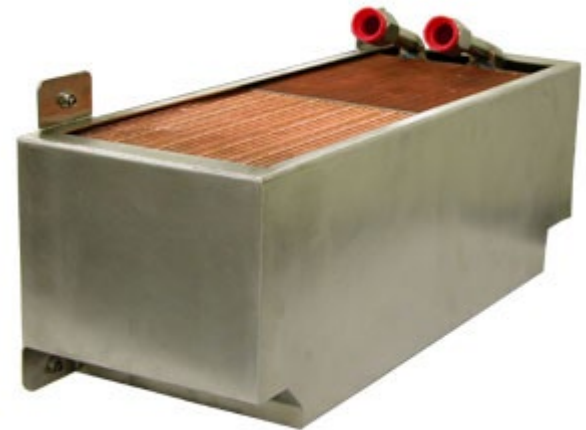
Case study 3 – Lytron

Phase II: Copper Fin and Tubing

- Looking for an aqueous/enzymatic option
 - Willing to do a rinse/dry step
- Clean fin and tubing parts within 30 minutes or less
- Must be able to remove Oak 15C expanding, bending and forming metalworking oil
- Looking to buy new equipment
