MINNESOTA POLLUTION CONTROL AGENCY

Optimizing Nutrient Treatment Wastewater Ponds: Gaylord, M N

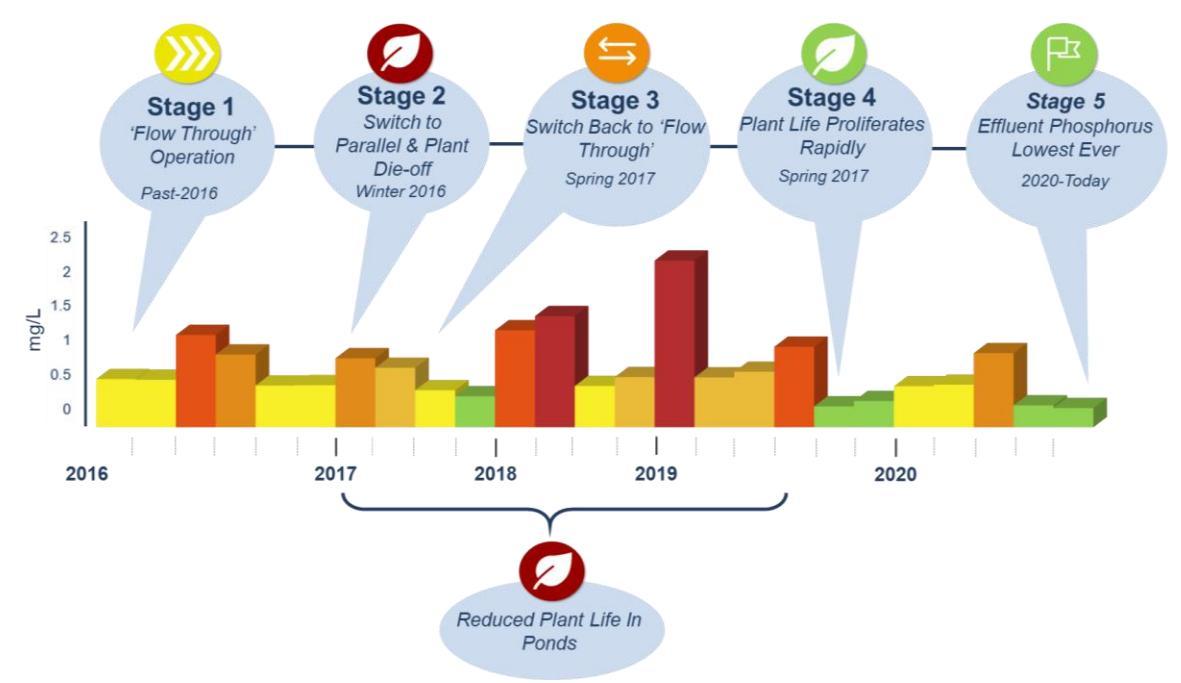
Timeline of Gaylord's Operation and Phosphorus Effluents

To understand how Gaylord achieved effluent phosphorus down to 0.285 mg/L, MnTAP's wastewater team investigated previous operational strategies taken by the pond operator. The timeline below shows the various stages of operation within the past few years, along with a table showing nutrient treatment.

Type of Operation ->	Parallel Flow and Reduced Plant Life (Oct 2016-Jun 2019)	Flow Through and Proliferating Plant Life (Sept 2019-Nov 2020)
Phosphorus Effluent AVG.	1.0 mg/L	0.522 mg/L
Phosphorus Removal	69%	81%
Nitrogen Effluent AVG.	4.6 mg/L	3.1 mg/L
Most Recent Phosphorus Effluent:	<u>Oct 2020</u>	<u>Nov 2020</u>
	0.325 mg/L	0.285 mg/L

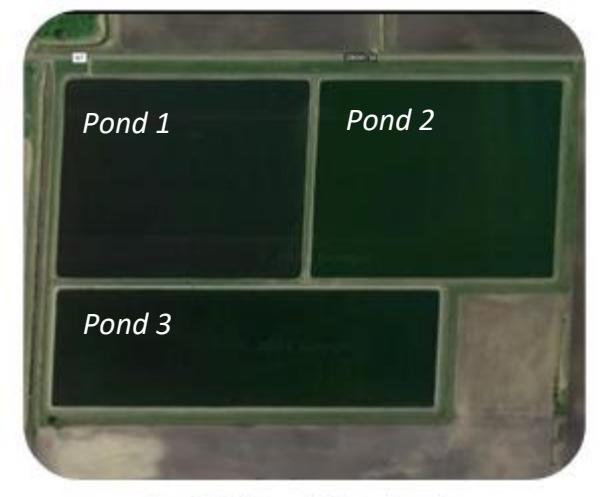
Aerial View of the Ponds

In Gaylord specifically, Robert held their large Pond 1 at 6' depth using a slide gate. Water was then allowed to cascade over the slide gate to fill Pond 2. Additionally, Robert had a second 'Flow Through' slide gate from Pond 2 to Pond 3 where water in Pond 2 was held at 4' before spilling over into Pond 3.

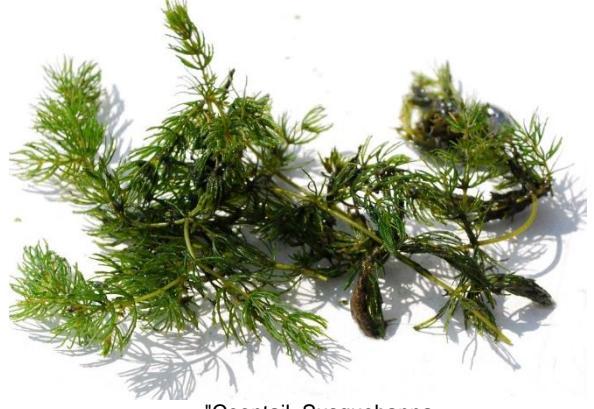
Coontail is an aquatic plant that naturally grows in many Minnesota wastewater pond systems. It is known to uptake nutrients as it grows and can therefore be a useful tool in achieving better treatment in pond systems. In Gaylord, the switch to parallel flow in 2017 most likely disrupted growing conditions and killed off any coontail. As seen in the charts below, after two years of switching back to the recommended 'Flow Through' method, coontail made more than a full comeback and is now flourishing in ponds where there was previously no growth. Providing conditions for coontail growth was another factor contributing to better nutrient treatment.
