COMPRESSED AIR LEAKS IN FOOD MANUFACTURING

Overview

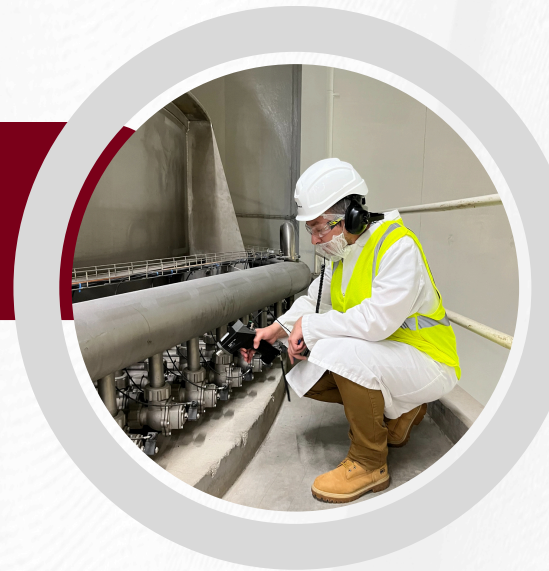
MnTAP staff typically use an ultrasonic leak detector to determine the location of compressed air leaks in a facility. These handheld devices detect high-frequency sound waves produced by air escaping under pressure. They filter out background noise while enabling pinpoint leak identification and accurate tagging for repair. The ultrasonic leak detector outputs a decibel (dB) reading. This dB reading and the system pressure can be used to calculate air loss in cubic feet per minute (CFM) based on reference charts, such

as this one supplied by UE Systems for their line of ultrasonic leak detectors. For example, a leak with a decibel reading of 20 dB and a system pressure of 150 PSI corresponds to a leak rate of 1.34 CFM. From there, the effective power loss, energy savings, and cost savings can also be calculated.
