2023 P2 Week – Day 5

Common P2 Practices in Dairy Processors

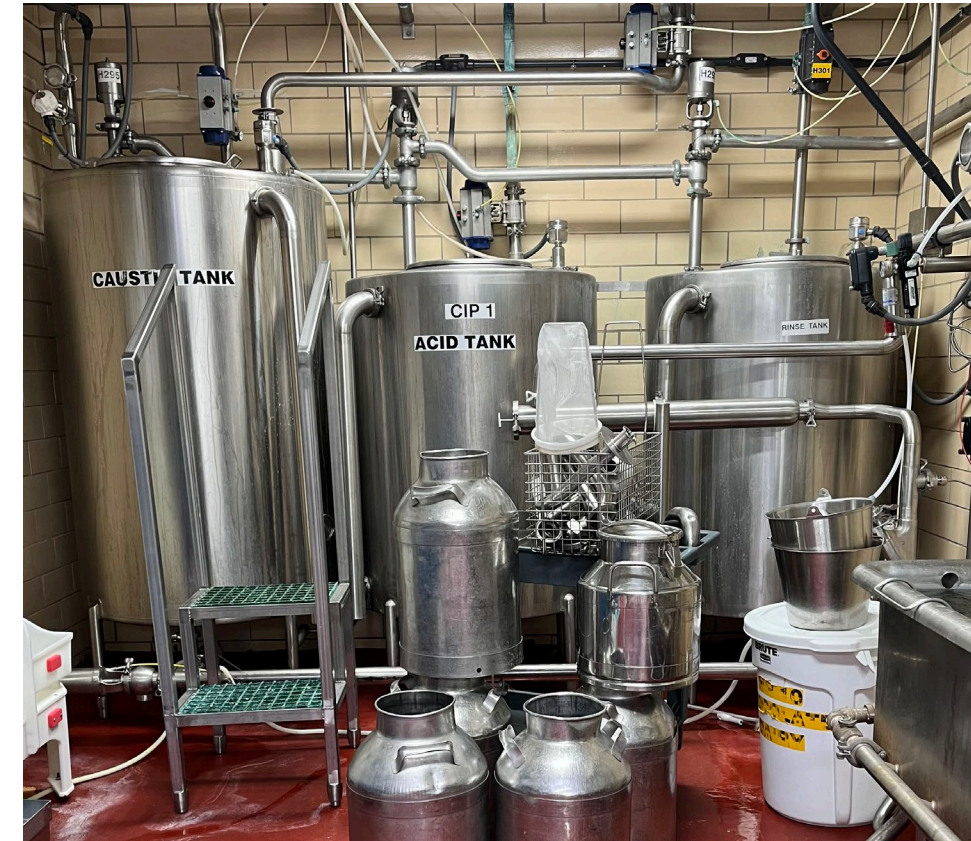
- Monitor conductivity and turbidity
- Establish and maintain standards

A Reuse CIP system
