Intern reduces powder coating waste and raw material use

A MnTAP Intern helped Ultra Image Powder Coating reduce the amount of waste material generated through the painting process, thereby reducing the raw material used and costs associated with purchase and disposal.

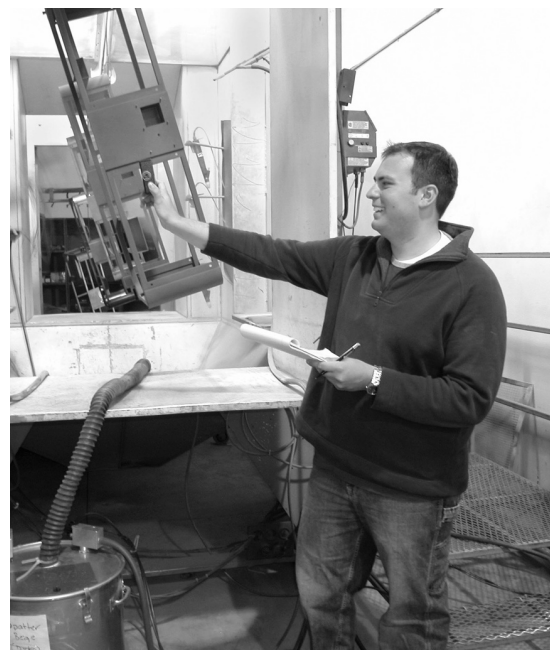
The MnTAP intern at Ultra Image tested the air flow in the powder coating booth to determine transfer efficiency.

Through research and observation, the MnTAP intern identified two major causes of low transfer efficiency for Ultra Image's coating process: high booth airflow and poor operator training. Several different options were suggested and implemented to address the low transfer efficiency. These options included precise airflow control, powder room pressurization, and suitable manual operator training. Each option was viable for increasing transfer efficiency, and an early goal was set to see

The MnTAP intern determined that ducting the air conditioner unit intake air supply to the outside would place the powder room under a positive air pressure, and reduce the costs associated with changing filters. A positive pressure in the powder room and outside air source for the air conditioner unit reduces the amount of wear that is experienced by the intake filters. Prior to the intern project, the filters were changed once a week, costing Ultra Image over \$3,200 annually in replacement costs. By pulling cleaner air into the air conditioner units, Ultra Image is extending each filter's life and potentially saving \$2,500 annually on filter costs. This savings almost covered the costs of installing the duct work and resulted in a payback period of nearly one year. Additionally, with the assistance of Ultra Image staff members, the MnTAP intern trialed several positions of air deflection plates, which are used to reduce the flow of air in the area of the part. The deflectors that were installed change the airflow and prevent the collection of powder before it reaches the parts.
